Loading Test Report

Approval office for construction
products

T-17-187659

Loading test report of Contruss permanent filler

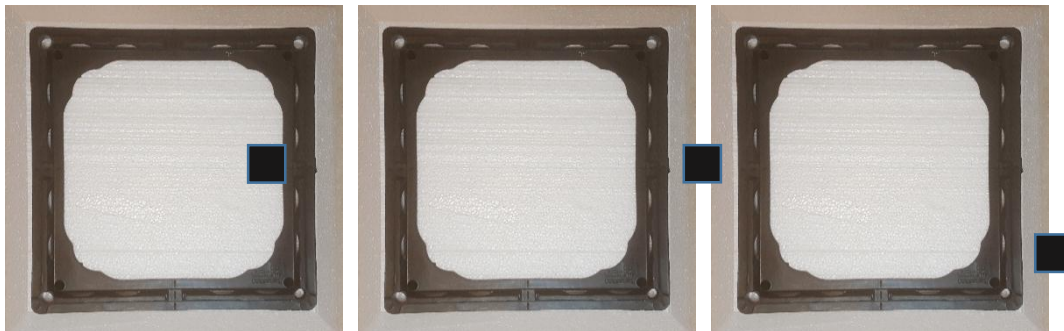
Loads are applied in three positions of middle, edge and corner on the fillers in this test. The area subjected to applied load is 8*8 cm. The load level is as much as 150 kg. Permanent deformation or fracture under the applied load is not permissible in the filler, trays and piles.

Figure 1. Locations of applied load

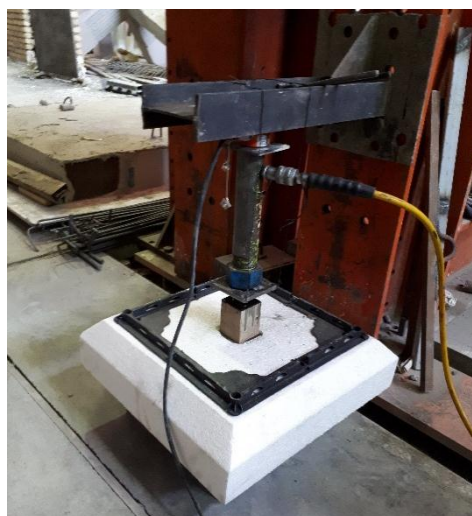
Figure 2. load applying on the center of filler

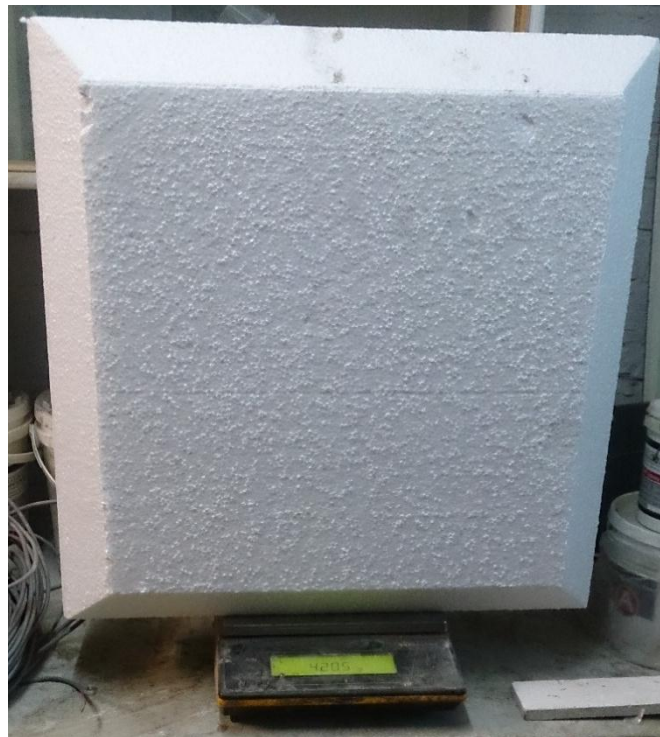
Three filler samples were presented to the CIBmt by the applicant. In addition, a polystyrene block sample has been received separately for density measurement. The fillers are made of polystyrene and also the upper and lower trays and pile are made of polypropylene. The polystyrene block dimensions are 55*55*20 cm and trays dimensions are 45*45 cm. Density of the expanded polystyrene used in the fillers was measured 8 kg/m³.

Figure 3. Weighing polystyrene block to measure density

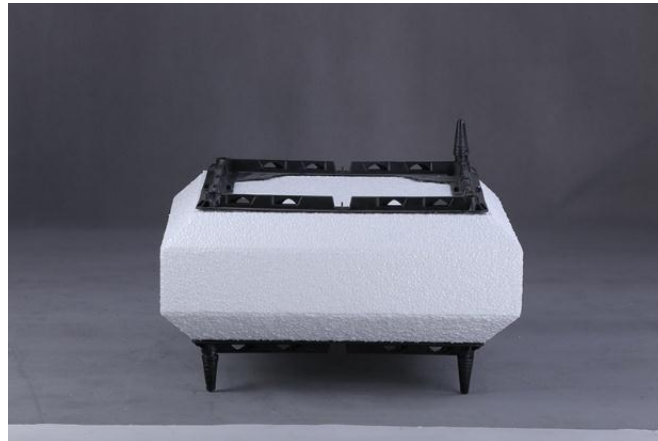
Figure 4. Side view of the filler

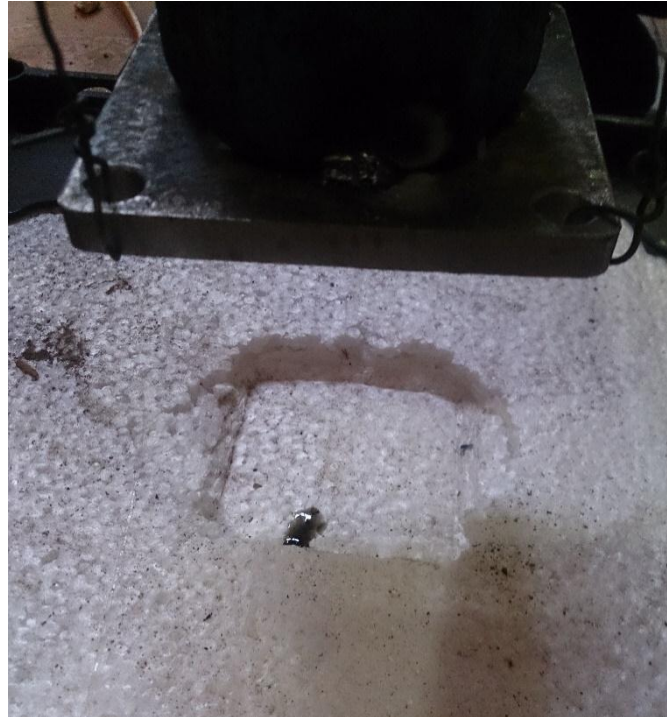
By applying load up to 150 kg, observations illustrated that none of the fillers are fractured, and also there is no permanent deformation in the fillers and no deviation in the piles. Due to compressibility of polystyrene, localized permanent deformation was observed in the location of applied load and the amount is presented in the following table.

Location of applied load on the filler	Amount of localized permanent deformation (mm)
1	Middle	12.65
2	Edge	8.46
3	Corner	4.15

Figure 5. localized deformation under location of load
